State of Nevada
Department of Administration – State Public Works Division
Buildings and Grounds Section
Marlette Lake Water System Office
Facility Condition Analysis

MARLETTE LAKE WATER SYSTEM OFFICE

Site Number: 9899
STATE OF NEVADA PUBLIC WORKS DIVISION
FACILITY CONDITION ANALYSIS

Report Printed in August 2015

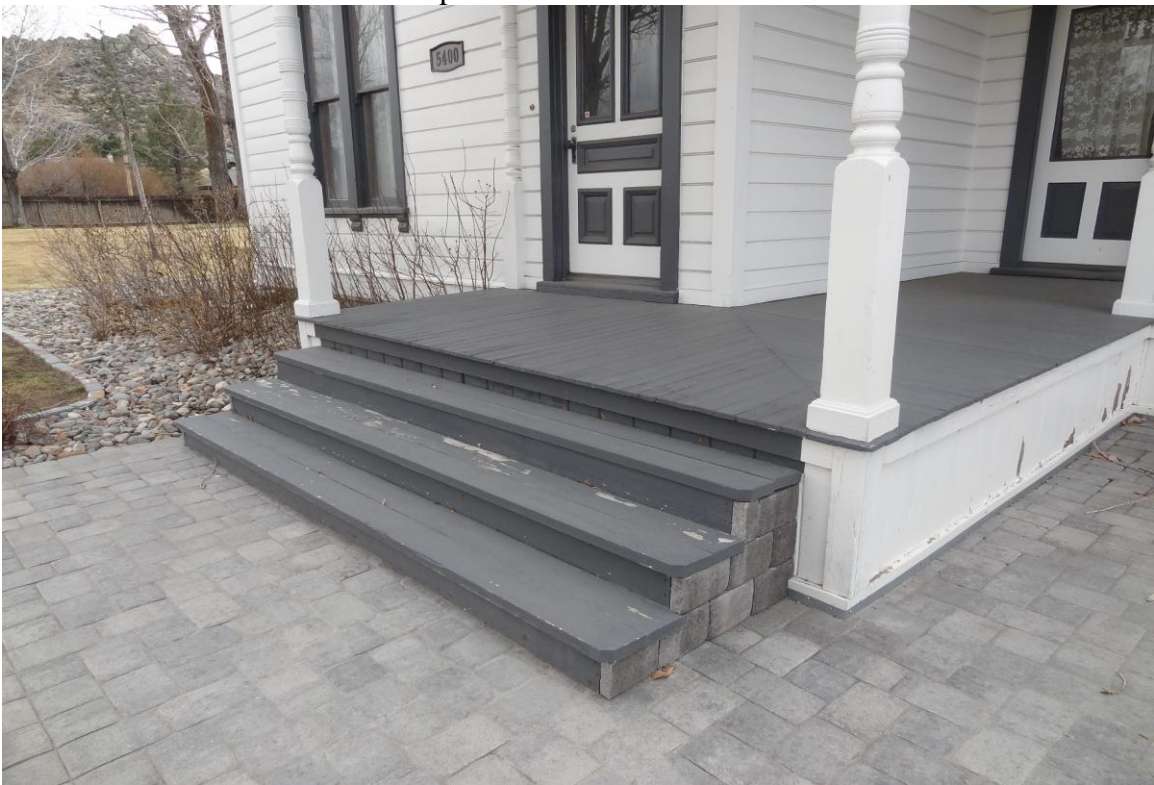
Lakeview House – FCA Building #2484

The exterior stairs and wrap around porch are lacking handrails and guardrails as required in section R311.7.8 of the 2012 International Residential Code. This project would provide for wood framed handrails and guardrails to be installed in accordance with the code. This project is contingent upon the approval of the State Historic Preservation Office. This project or a portion thereof was previously recommended in the FCA report dated 02/18/2005. It has been amended accordingly to reflect conditions observed during the most recent survey date of 02/25/2015.

Description: Main entry stairway to residence.
